## CITY OF SPRING LAKE PARK

SPRING LAKE PARK
CITY ADMINISTRATION, POLICE,
PARKS/REC & PUBLIC WORKS
FACITILY & SPACE NEEDS
ASSESSMENT

FINAL REPORT MAY 10, 2017

LEO A DALY NO. 023-10232-000

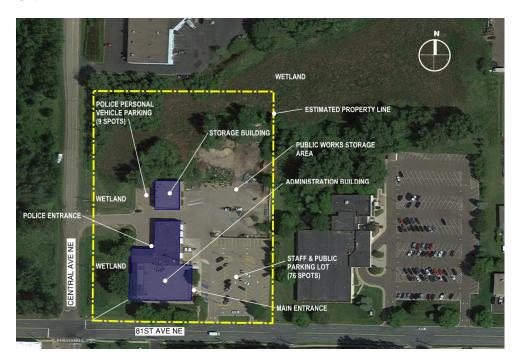
Figure 1. City Hall aerial view

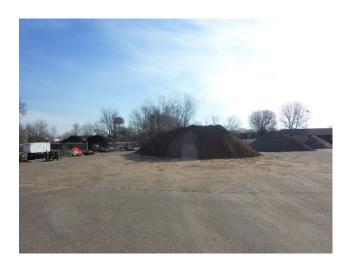
Figure 2. Public Works storage area

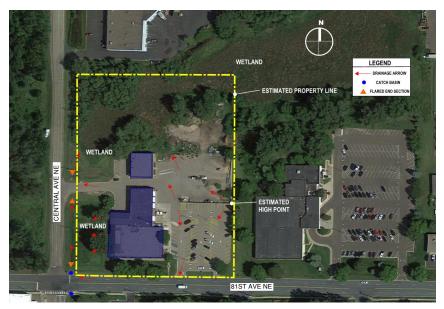
Figure 5. Estimated Site Drainage

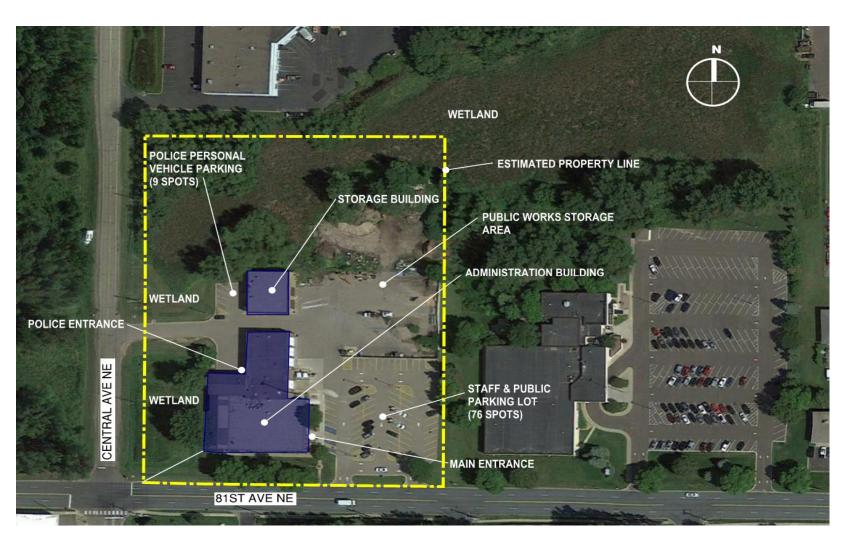
- Removal of fuel tank requested. Testing recommended;
- Resurfacing of parking is recommended maintenance;
- The appears to be a wetland to the north, with water draining from south to north.
   Delineation of the wetland is recommended;
- require replacement, of 2:1 or credits required;

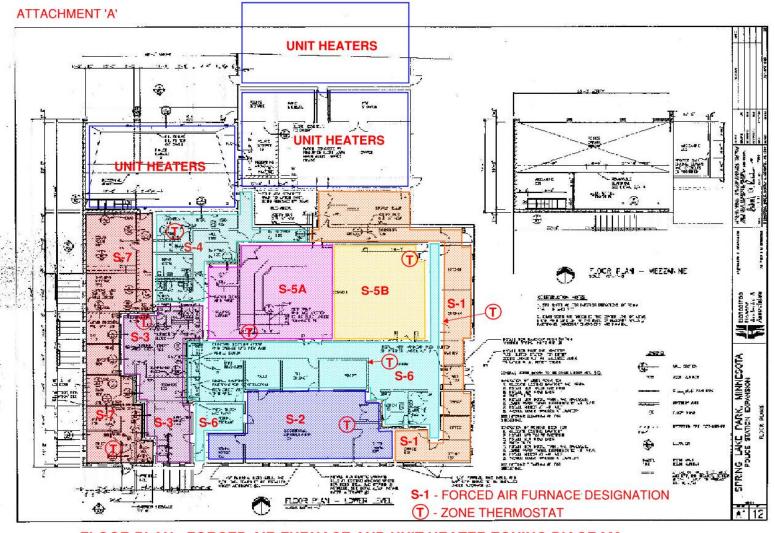
FLOOR PLAN - FORCED AIR FURNACE AND UNIT HEATER ZONING DIAGRAM

- The City Hall building is served by six forced air furnaces last replaced in-kind in 1998-1999 (18 years old);
- The police expansion is serviced by 1 forced-air furnace, circa 1994 (23 years old);
- Exhaust systems are original to the building (40 years old);
- Water heater is at end of useful life;
- No fire suppression;

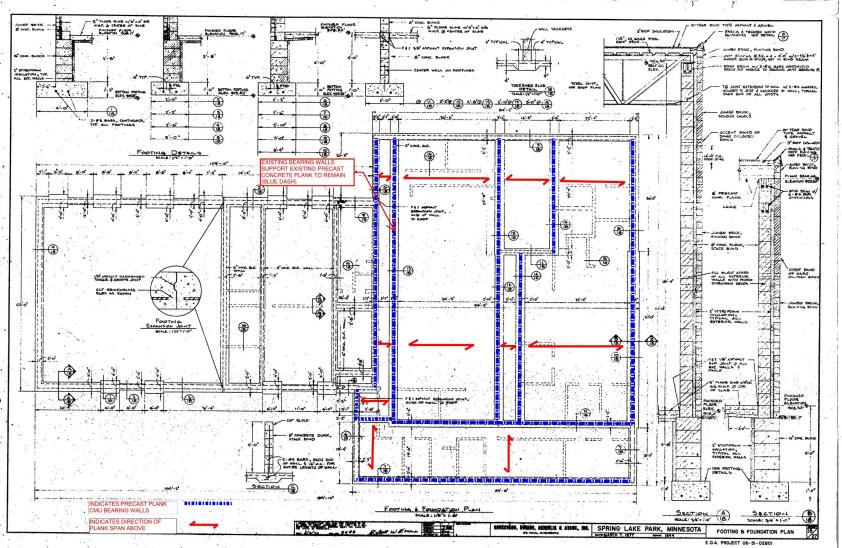
- The City hall / Parks portion of the building CAN be capable of a second floor addition for office function only.
- Blue walls are load bearing and would need to remain in place;
- The police expansion is not capable of a second floor addition;
- The garage space is not capable of a second floor addition;
